# Dark spots/Flux staining/Ash Inclusions- A byproduct of the galvanizing process.

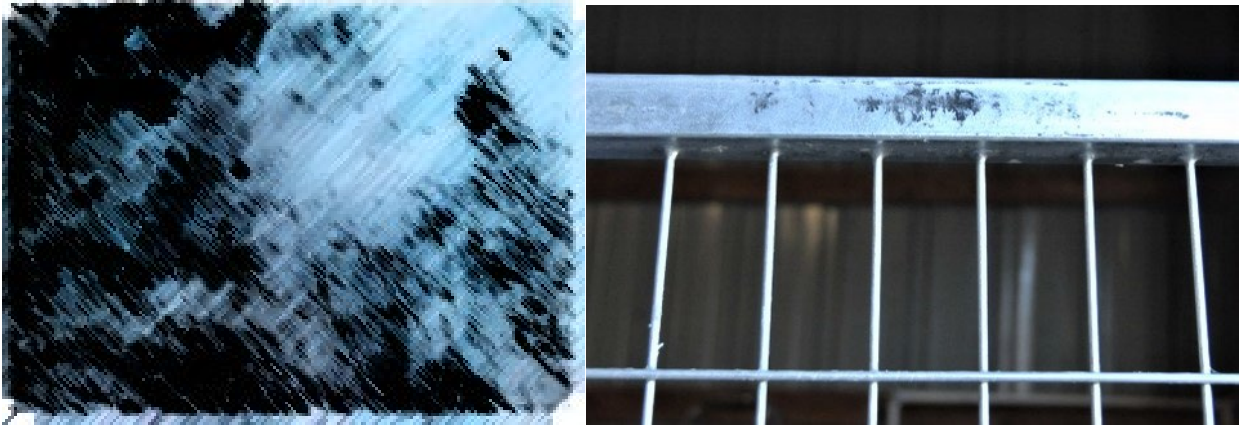
General comments: Acceptable, some spots can be removed. A sound finish is typically under the discoloring.

Smuts of dirt may be picked up on the surface of the galvanized coating from floors and trucks or from contact with other articles. Most smuts are readily washed off to reveal a sound coating and are not harmful. Small spots of surface rust are also common and are just on the surface and do not affect the longevity or finish below.

Where a flux blanket is used in the galvanizing process, stale flux may adhere to the surface of the work during immersion and appear as a black inclusion in the coating. Black stains or deposits of flux picked up on the surface when the object is withdrawn from galvanizing the bath do not warrant rejection.
